Docket No. 217 – Development and Management Plan Inspection

Northeast Utilities Service Company Certificate of Environmental Compatibility and Public Need for the construction of a 345-kV electric transmission line and reconstruction of an existing 115-kV electric transmission line between Connecticut Light and Power Company's Plumtree Substation in Bethel, through the towns of Redding, Weston, and Wilton, and to the Norwalk Substation in Norwalk, Connecticut.

Date: July 6, 2005

Location: 115 kV Underground Route

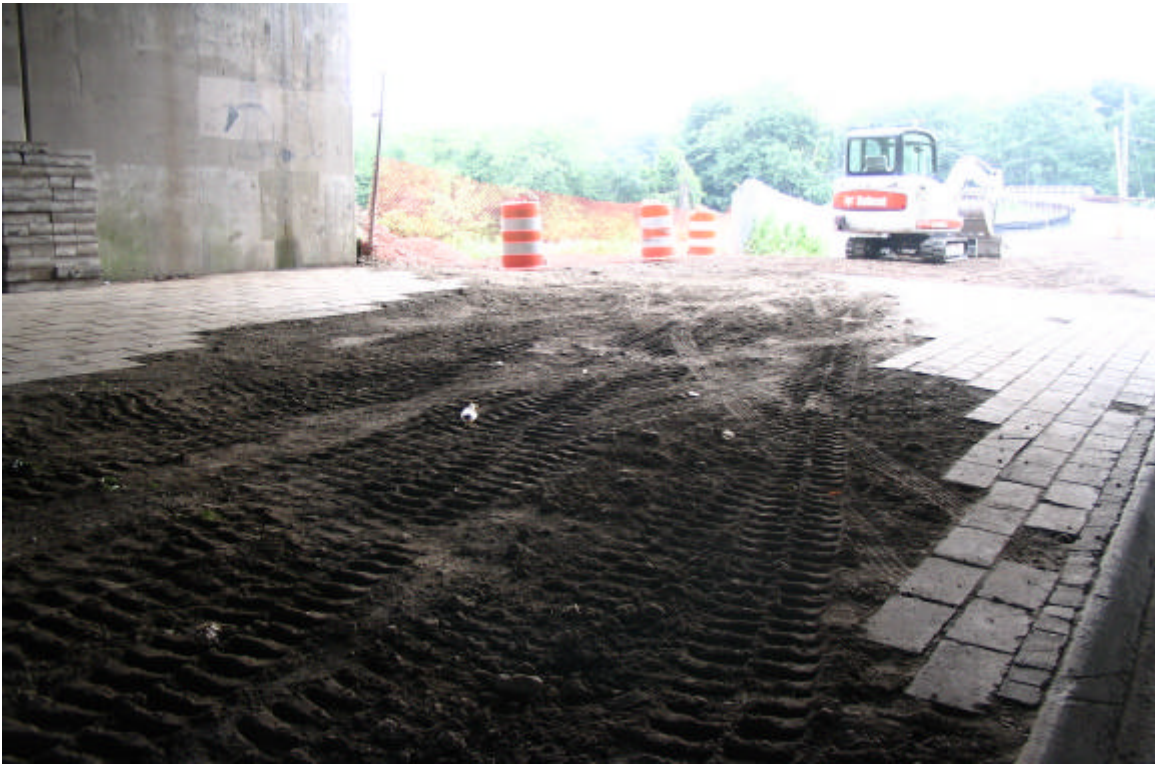
115 kV (Broad Street-Norwalk): Ductwork has been completed in the ROW and is now occurring in the roadway shoulder of Broad Street. 7/6/05

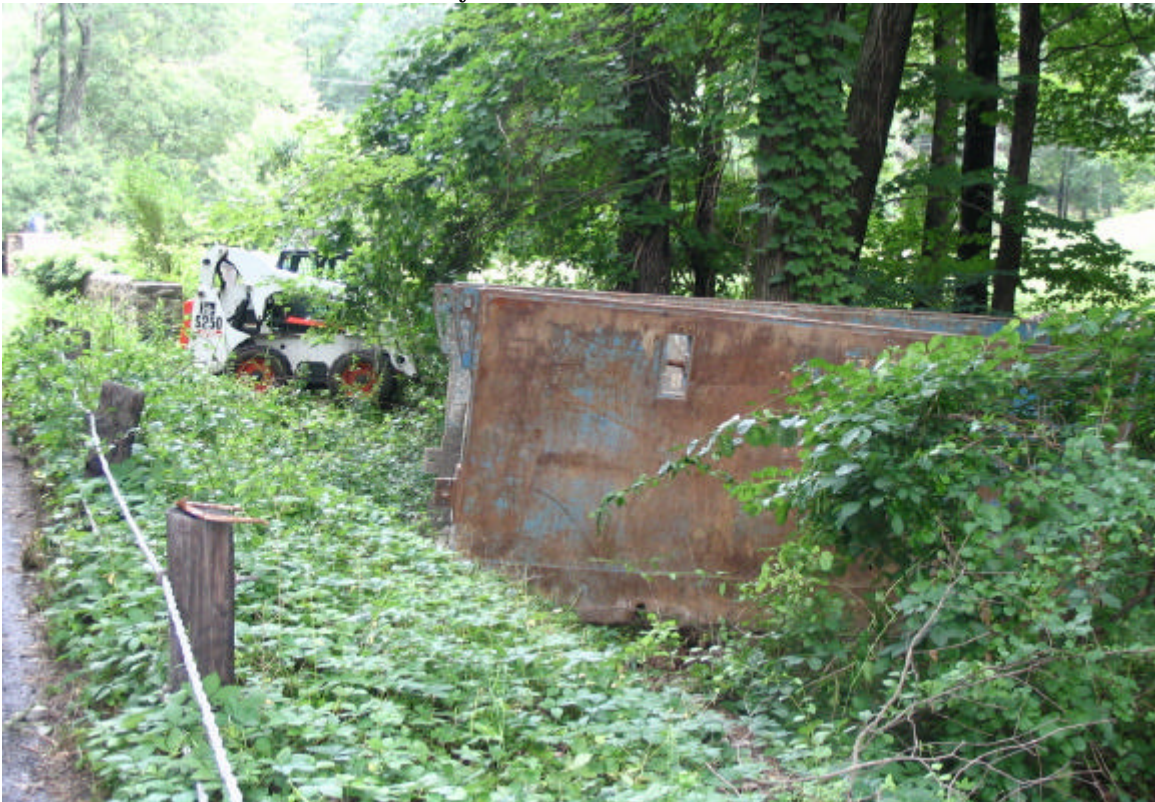
115 kV (Gallows Hill Road, Redding): Trench boxes and equipment were placed off the roadway in the woods. This should be limited to designated pull-off areas. 7/6/05

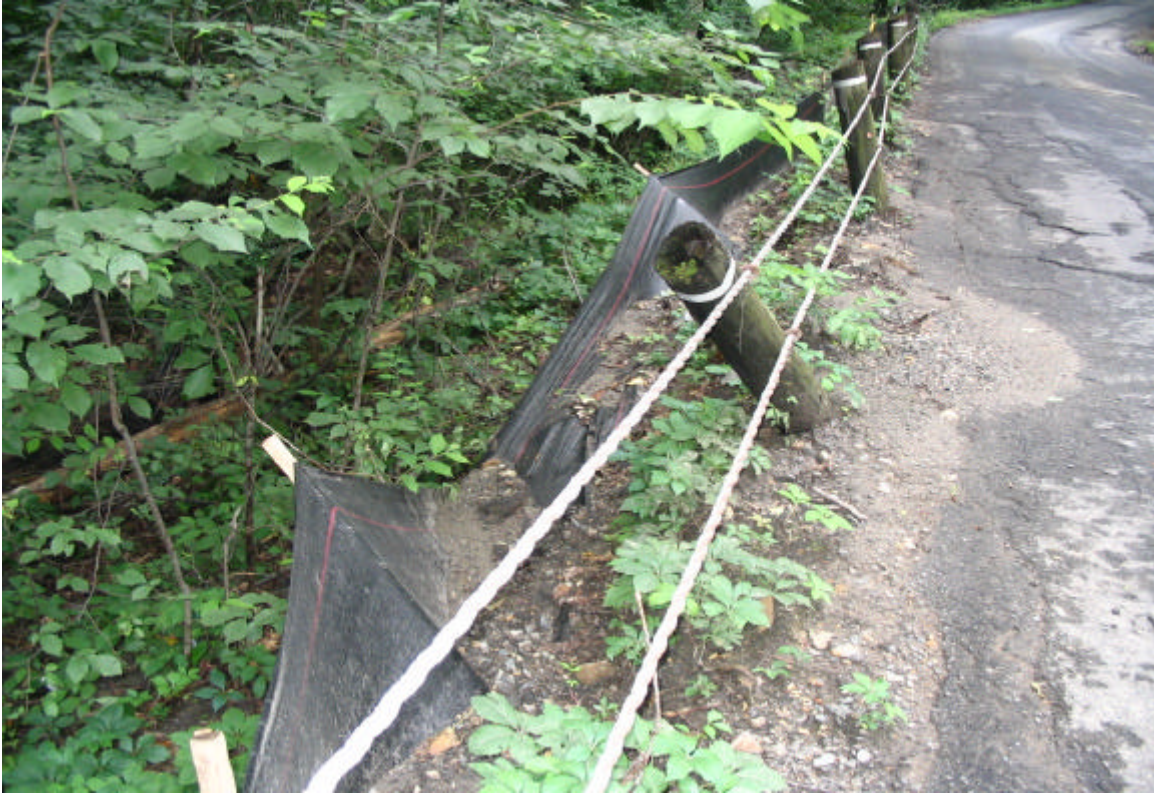
Silt fence in need of repair ASAP in the vicinity of #116 Gallows Hill Road. Stormwater has overtopped the fence and deposited some sediment beyond. 7/6/05

Gallows Hill Road and Rt. 107 (Lonetown Rd)	<ul style="list-style-type: none"> - One area of fence near #116 Gallows Hill has been pushed over and sediment has overtopped. Some sediment was noted in the wetland beyond due to run off from the roadway. 7/6/05 	<ul style="list-style-type: none"> - Active work is not located in the vicinity but a vault was installed here and the pull off with stone piles remains. The soil is not fully stabilized. The sediment beyond the fence is minor and would be more damaging to remove, but the fence should be repaired ASAP. 7/6/05.

Adjacent Wetlands and Waterways	<ul style="list-style-type: none"> -With the exception of the small amount of sediment which overtopped the silt fence on Gallows Hill, no sedimentation or turbidity have been noted in the 	<ul style="list-style-type: none"> -The amount of sediment is very minor and would be more disruptive to remove at this point. The fence should be repaired ASAP. 7/6/05

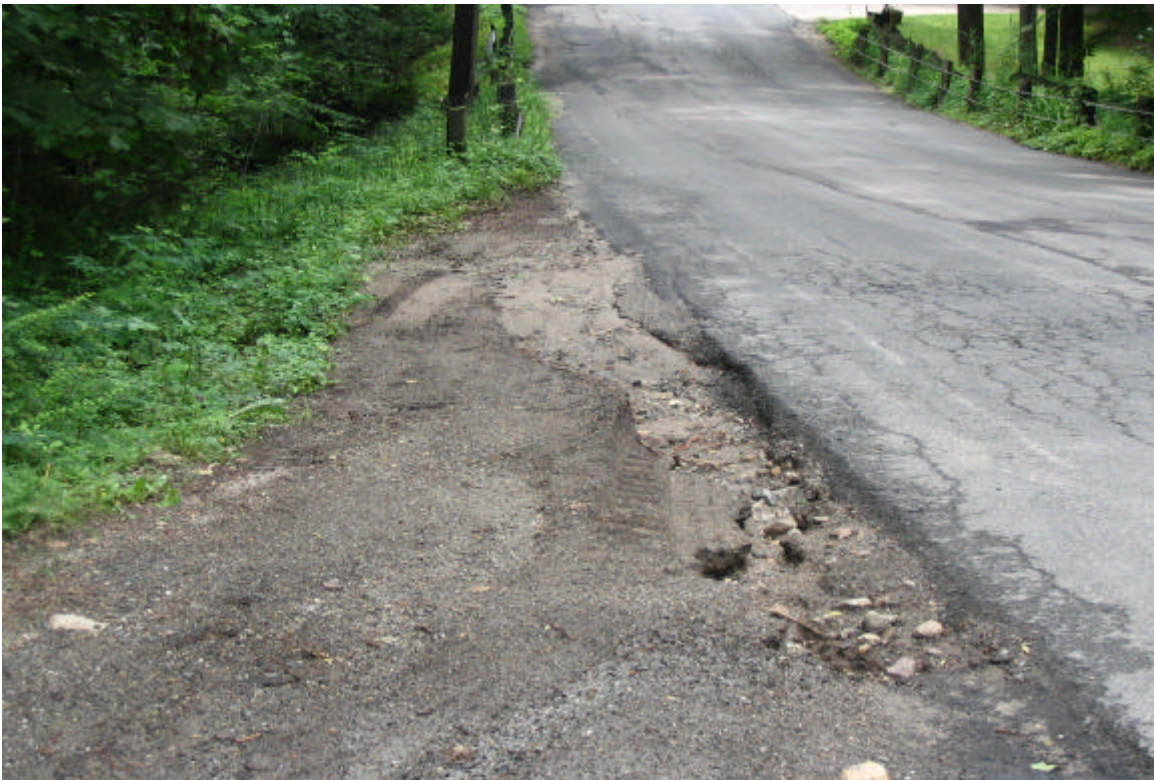
Some sedimentation has occurred along the roadway shoulder at the designated pull-off on Gallows Hill. Silt fence or haybales should be extended to the road. 7/6/05

Areas of Inspection	Observation	Recommended Action
Gallows Hill and Lonetown Rd. continued	<ul style="list-style-type: none"> - The eroded asphalt at the edge of the trench had been repaired. 7/6/05 - The original pull-off area has some sedimentation that occurred along the roadway shoulder. 7/6/05 - The area along Rt. 107 near the Redding Country Club pond still requires repair of the silt fence. It has come “untoed” and ripped down. 6/15-7/6/05 - Another section of silt fence at the intersection of Rt. 107 and Gallows Hill should also be toed in where stormwater has flowed through. 7/6/05 	<ul style="list-style-type: none"> - None at this time. 7/6/05 - A check dam should be installed from the original silt fence to the edge of the road to prevent the sediment from entering a swale here. 7/6/05 -Active work is coming this way and silt fence should be repaired/toed prior to trench work in both of these areas. 7/6/05

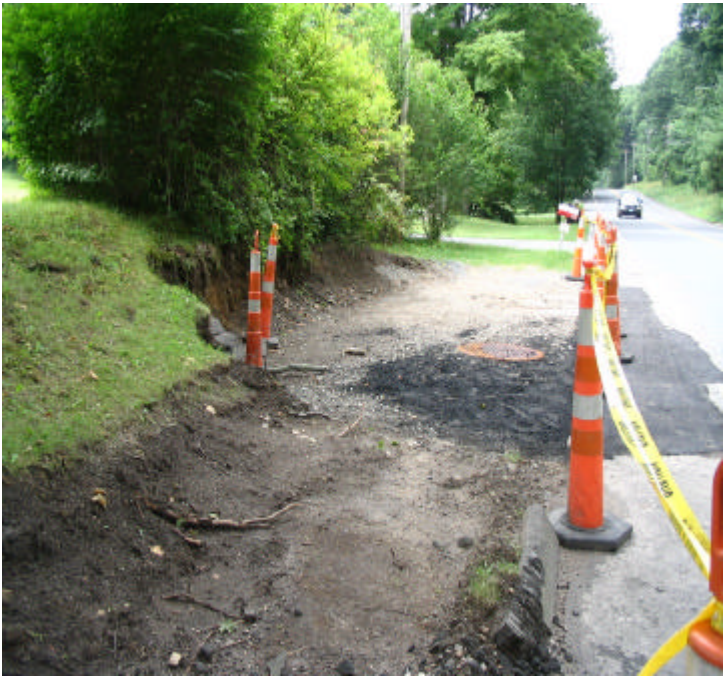
115 kV (Route 107, Redding)- View of the recent vault installation along Lonetown Rd. The area still requires temporary stabilization. 7/6/05

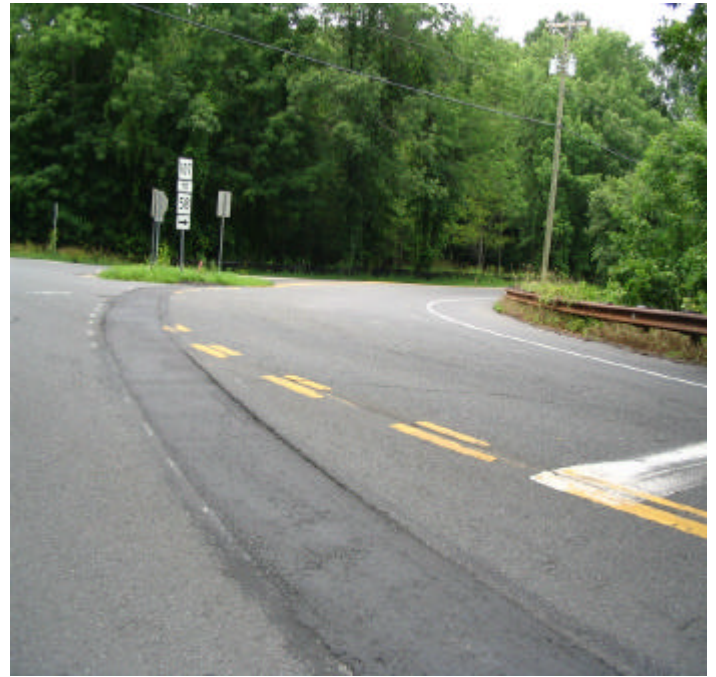
View of the trench turning the corner from Putnam Park Rd (Rt. 107) to Lonetown Rd. (Rt. 107).

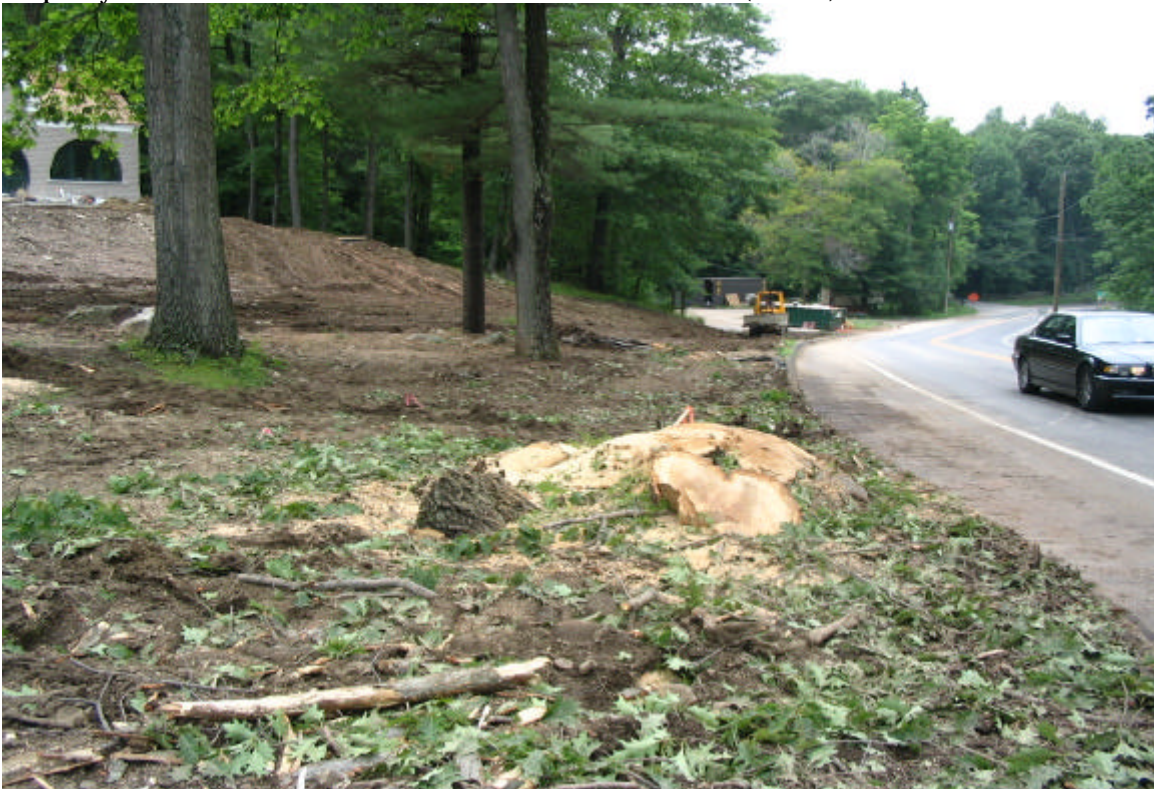
115 kV (Route 107, Putnam Park Redding)- Two larger red oaks were removed from the Putnam Park area for the trench alignment. They will be replaced by several smaller trees. 7/6/05

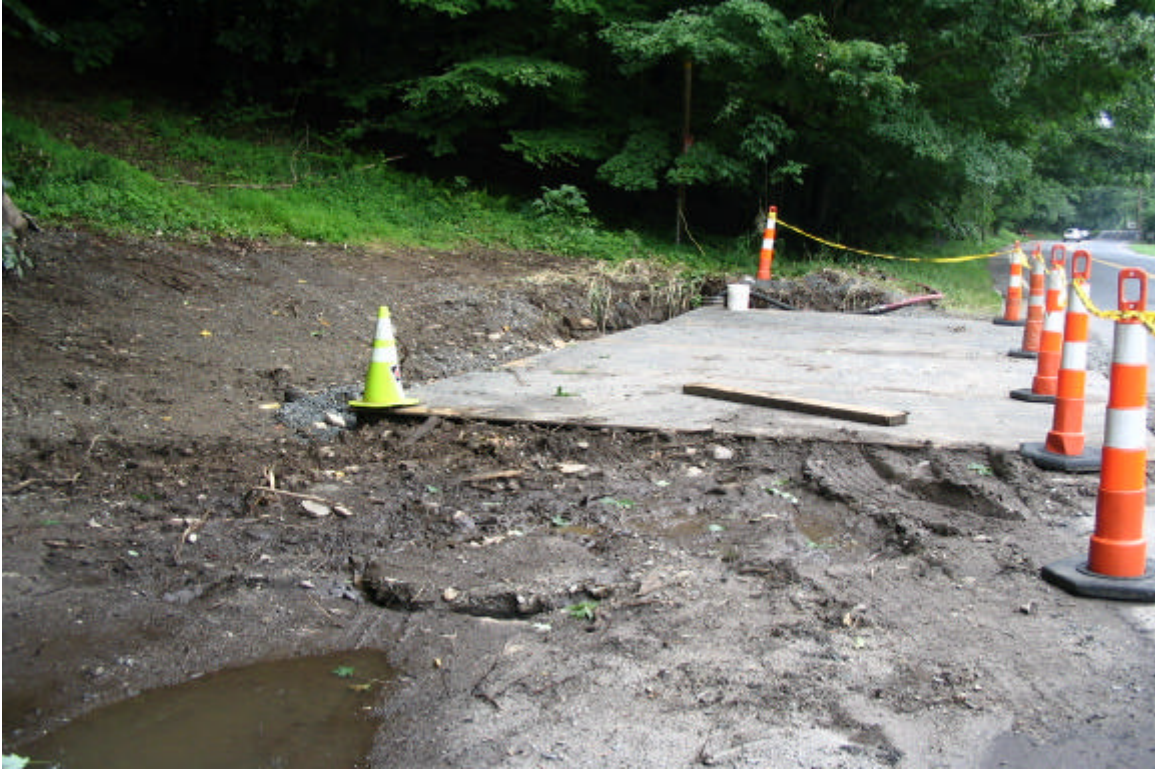
115 kV (Route 58, Redding): Ongoing vault installation off road shoulder. Silt fence could be installed along the base of the slope to prevent erosion. 7/6/05

Areas of Inspection	Observation	Recommended Action
Route 58	<ul style="list-style-type: none"> - The vault installation here could use some additional silt fence as it is at the base of a steep grade cut. 7/6/05 - Work is just beginning along Rt. 58 and fence along this roadway should be monitored. 6/29-7/6/05 	<ul style="list-style-type: none"> - Silt fence placed on the grade above the vault as a check dam should help prevent erosion of the slope and sedimentation to the vault. This area should be restored and stabilized. 7/6/05 - Be proactive in silt fence maintenance and repair. 7/6/05
Rt. 58 and Rt. 107 Putnam Park Road portion, Redding	<ul style="list-style-type: none"> - The silt fence in disrepair at the intersection of Rt. 58 and Rt. 107 belongs to the work at Putnam Park. The trench has not come through this area yet. 7/6/05. - Active work in the lot for Putnam Park is part of a separate park project and materials are no longer being stored for the 115kV project here. 7/6/05 	<ul style="list-style-type: none"> - None at this time. 7/6/05 - Separate active work on the park is ongoing and they are responsible for maintaining controls here. 7/6/05

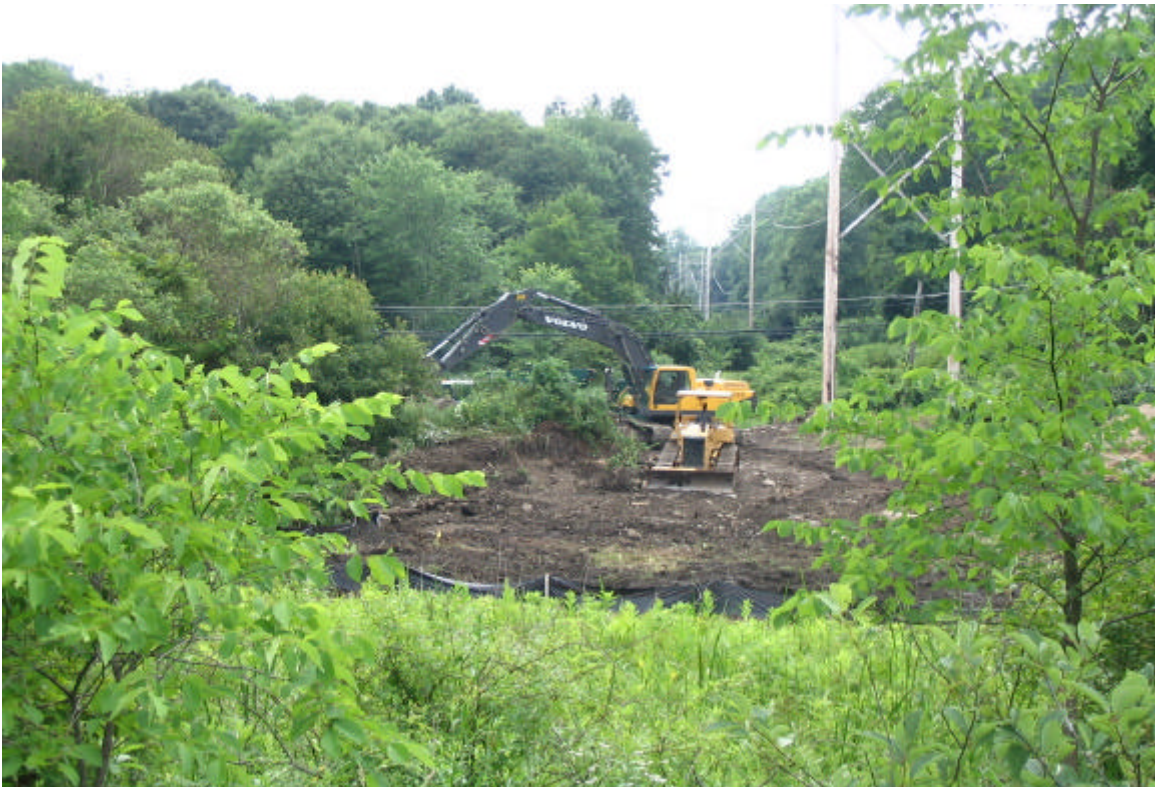
Work within the ROW at Hoyts Hill Road but not associated with the current 115kV project. Silt fence is in place. 7/6/05

<ul style="list-style-type: none"> - Excavation was occurring in the ROW off Hoyts Hill but this work is not part of the current 115kV. 7/6/05 	<ul style="list-style-type: none"> - Silt fence is in place but work is right up to the wetlands. 7/6/05

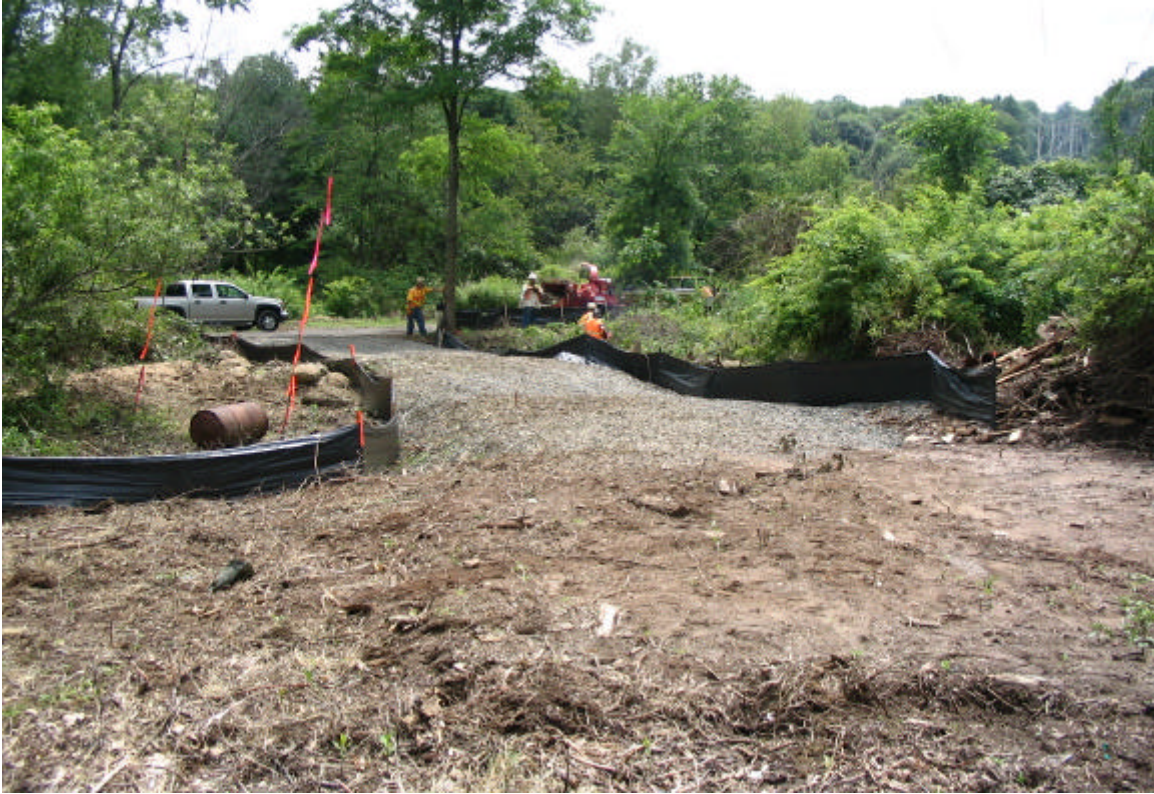
115kV (Hoyts Hill Road Transition): Vegetative clearing and a temporary road built to access the Hoyts Hill Transition station. 7/6/05

<ul style="list-style-type: none"> - The area cleared for the transition structure here could use additional silt fence (check dams) to prevent erosion down the grade. 7/6/05 	<ul style="list-style-type: none"> - Install a check dam of silt fence across the top of grade on the larger cleared area to prevent erosion. 7/6/05
Hoyts Hill Road (Off Rt. 58)	<ul style="list-style-type: none"> - The pull-off leading to the transition station across from Hoyts Hill Rd is being cleared and a gravel access road has been built. Mulch/chips from the clearing has been placed in a wetland area over the silt fence. 7/6/05 	<ul style="list-style-type: none"> - Now that the area is confirmed as wetland, the mulch/chip pile will be removed by hand. 7/6/05
	<ul style="list-style-type: none"> - The chip blower was also directed to a wetland area across the access road. 7/6/05 	<ul style="list-style-type: none"> - The blower was redirected to an upland area at the time of the inspection. 7/6/05

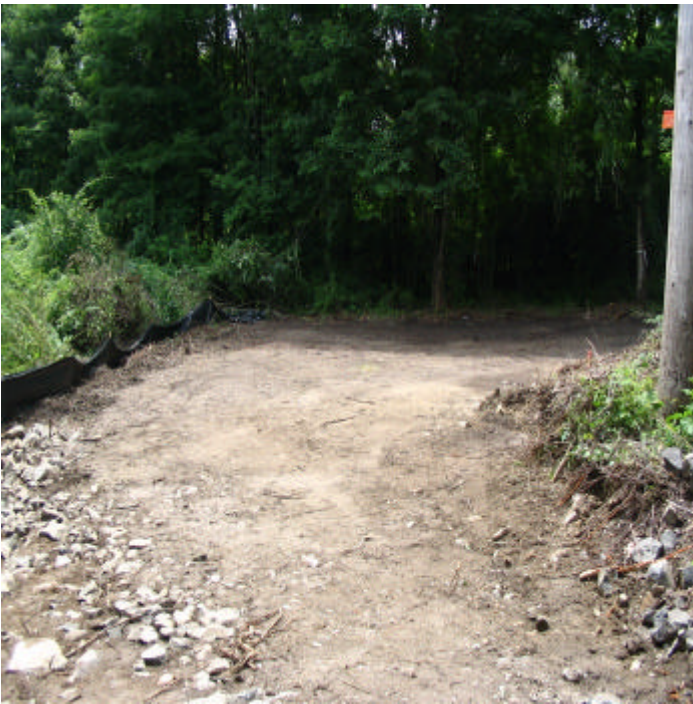
115kV (Bethel Educational Park) View of where the underground work will end in the ROW at a transition structure.

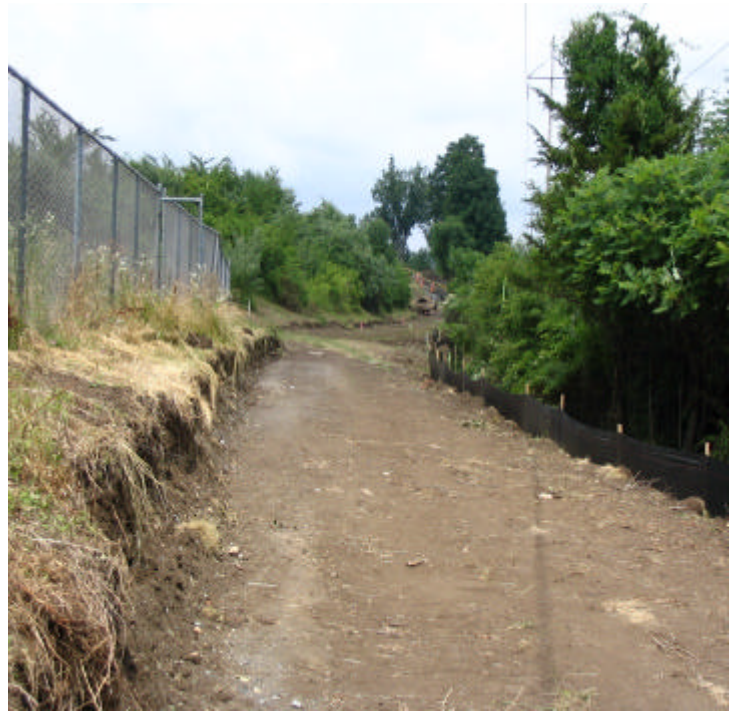
View of the cleared area within the existing ROW in preparation for the underground work. 7/6/05

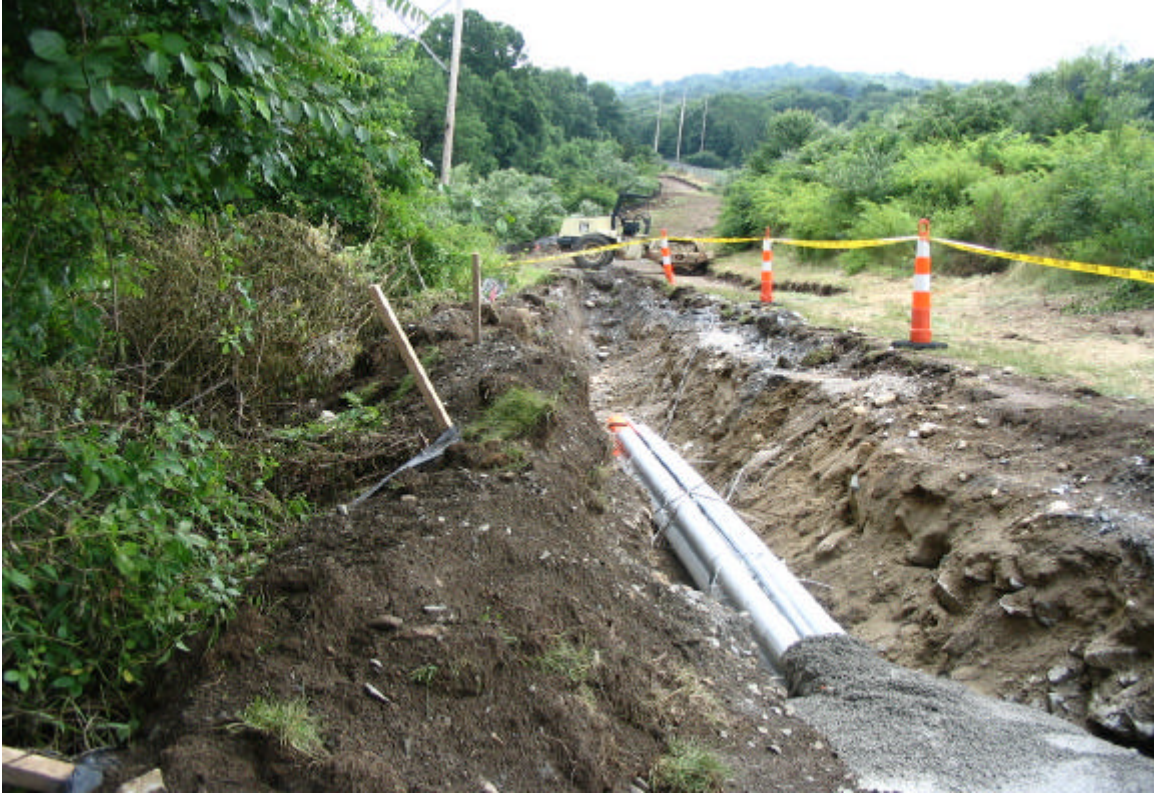
View of the ductwork installation within the Bethel Educational Park ROW. The silt fence in this area has been overtopped by the excavate and must be repaired ASAP. 7/6/05

Areas of Inspection	Observation	Recommended Action
Bethel Educational Park	<ul style="list-style-type: none"> - Ductwork has entered the Park near the Ralph Johnson School under the ROW. Silt fence is in place along the edge but several boulders have rolled against the fence and caused some strain. 7/6/05 	<ul style="list-style-type: none"> - Keep the controls in good repair and pull back boulders or soil which may strain the fence. 7/6/05
	<ul style="list-style-type: none"> - Ductwork continues in the ROW near the Bethel Middle School. Stockpiles have overtopped the silt fence here in several locations and a steep grade is located below. 7/6/05 	<ul style="list-style-type: none"> - The contractor will install additional fence behind the piles to keep them contained. Spoil piles will be placed on the other side of the ROW once it is feasible. 7/6/05
	<ul style="list-style-type: none"> - The silt fence further along the ROW has several spots where it has not been toed in although riprap present here may provide some filtration. 7/6/05 	<ul style="list-style-type: none"> - Silt fence should be toed in these locations unless the riprap is shown to filter out all sediment 7/6/05

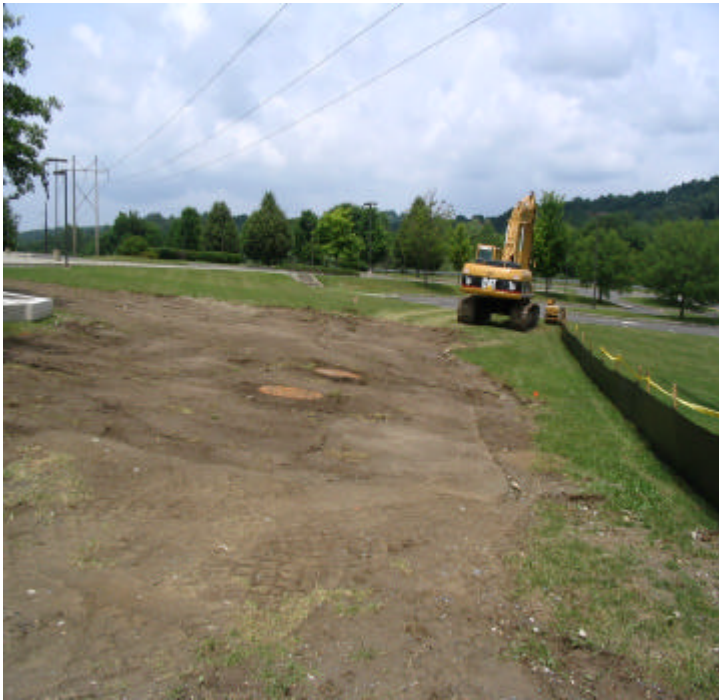
View of the recent vault installation in front of the Bethel Middle School. The lawn will be restored.

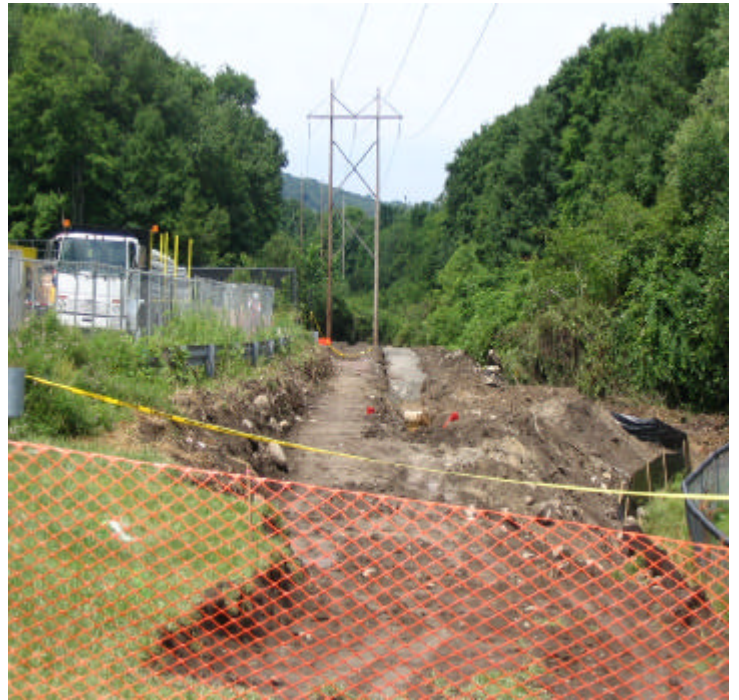
View of the ROW as it comes into the Bethel Educational Park. Ductwork/installation has begun in this area. 7/6/05

Areas of Inspection	Observation	Recommended Action
Vault Openings and Trench Construction Bethel Educational Park, Bethel	<ul style="list-style-type: none"> - Trenching and ductwork/ installation has begun in the Bethel Educational Park under the existing ROW. Portions of active work are located coming into and leaving the school grounds. 7/6/05 - Contractors are putting in effort to make sure the areas are cordoned off with safety fence and caution tape. 7/6/05 - A vault had been installed in front of the Bethel Middle School. 7/6/05 	<ul style="list-style-type: none"> - Some erosion controls in this area require repair. See erosion control, dewatering and storage sections for more specific information. 7/6/05 - The area had been backfilled and graded for now. 7/6/05
Gallows Hill Road and Rt. 107 Lonetown Rd, Redding	<ul style="list-style-type: none"> - Ductwork/installation is ongoing on Gallows Hill Road. 7/6/05 - Active work was not observed during the inspection again due to reports of inclement weather. Most areas were shut down for the day. 7/6/05 	<ul style="list-style-type: none"> - Activities seem contained on the roadway for the most part but a few issues require some attention. See erosion control, and storage sections for more specific information. 7/6/05
